MODEL
Sorento

DATE
December 2004

TECHNICAL SERVICE BULLETIN

SORENTO DIGITAL CLOCK LOSING TIME

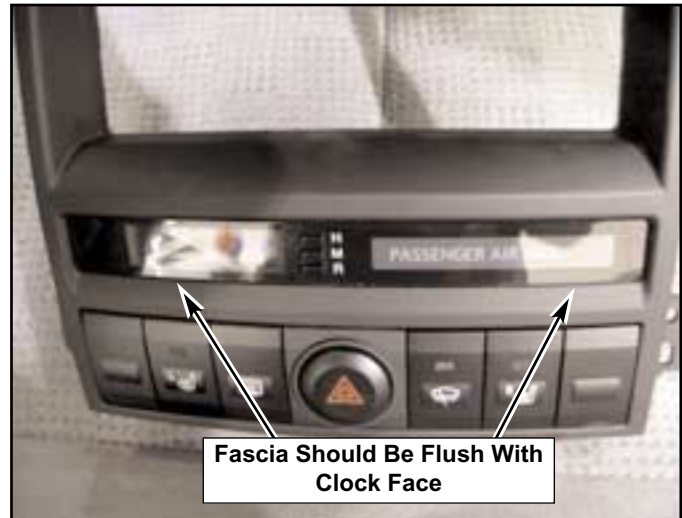
Fascia Should Be Flush With Clock Face

1. Clip the clock assembly onto the fascia panel. Make sure that the clock is flush with the front of the fascia panel.
2. Install three (3) retaining screws for the clock assembly.
3. Connect electrical connectors to the fascia panel. Most electrical connectors are color coded to the sticker on the switch.
