NUMBER
003 (Revision 4)

DATE
May 2006

TECHNICAL SERVICE BULLETIN

KIA AUTOMATIC TRANSMISSION PROGRAM

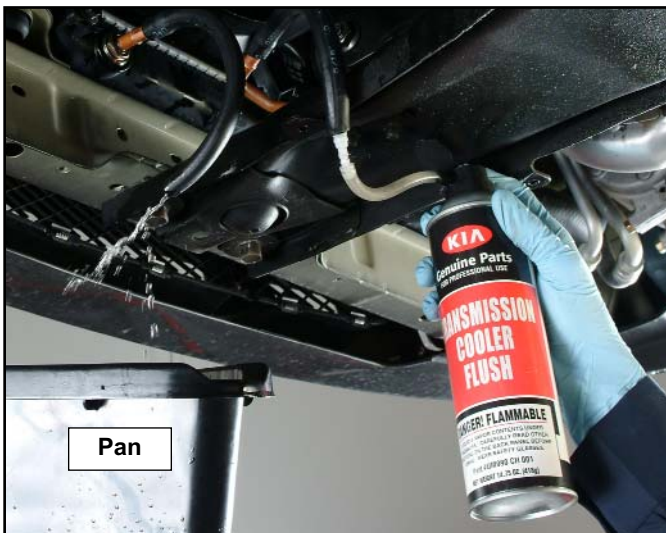
**Flushing Through A/T Cooler Outlet Hose
(Sephia/Spectra/Rio Shown)**

1. After removing the A/T from the vehicle, locate the A/T cooler outlet hose (refer to Kia service information).

2. Insert the nozzle of the Kia Transmission Cooler Flush into the A/T cooler outlet hose and secure with the metal spring clamp. Place a waste container under the other hose (A/T cooler inlet hose).

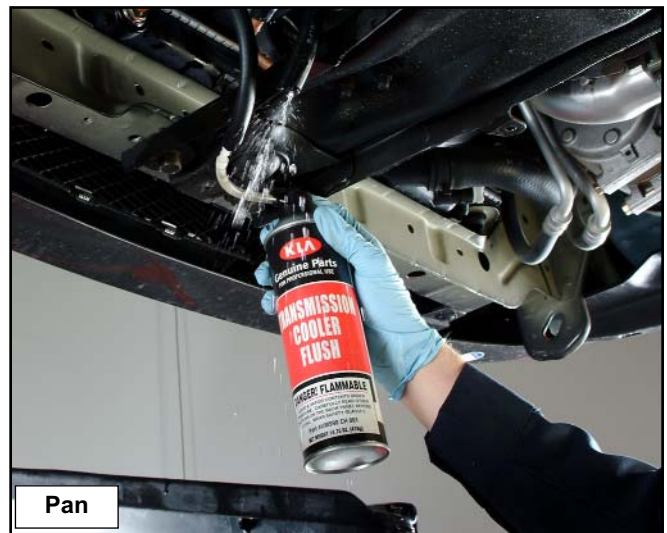
**Flushing Through A/T Cooler Inlet Hose
(Sephia/Spectra/Rio Shown)**

3. Hold transmission cooler flush can upright, remove protective flip-up cap and press button to release the flushing fluid. Continue to hold the button until clear liquid comes out of the cooler inlet hose.
4. Reverse the hoses and flush the cooler in the other direction until clear liquid comes out of the cooler outlet hose. Use the entire contents of the can to ensure thorough A/T cooler flushing.

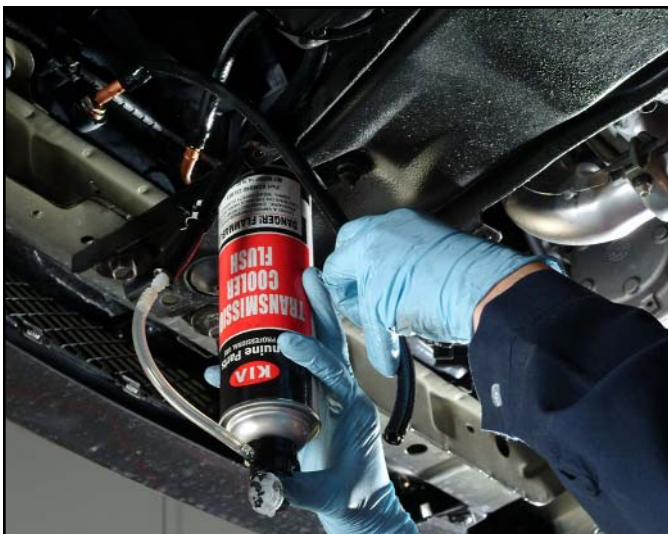
Invert Can to Clean Out Flush Fluid

5. After all of the flushing fluid is used, turn the can upside down and blow any remaining liquid out of the A/T cooler with transmission cooler flush propellant. After disconnecting the transmission cooler flush can, blow shop air (approximately 90 psi) through the cooler (in both directions) to dry it out.

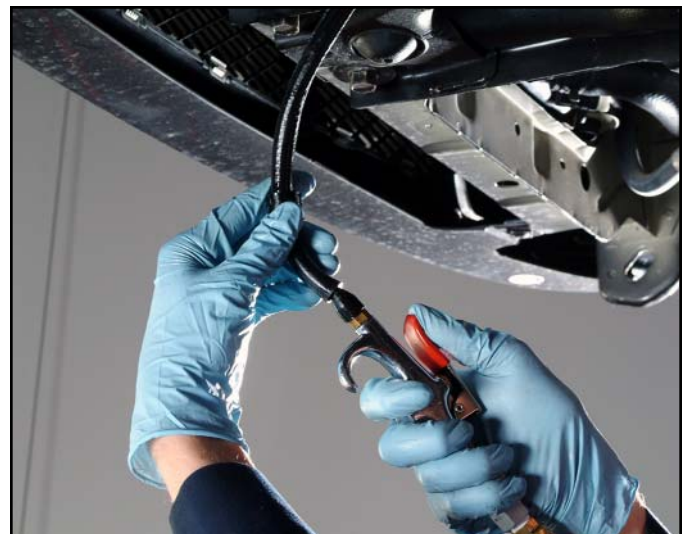
Drying A/T Cooler With Shop Air

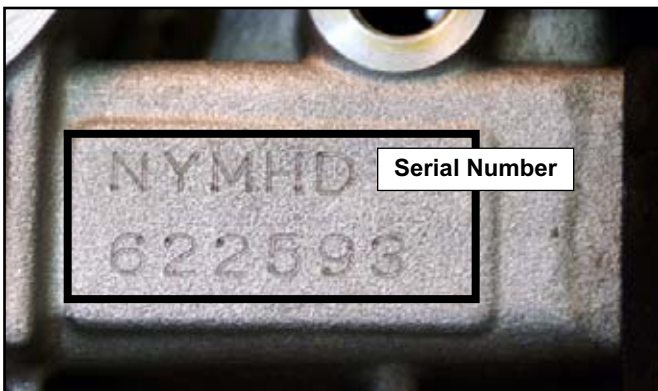
**New Style OEM
Serial Number**

Note: Record serial number of removed unit on Form WRTY 127 3/06 for ALL A/T replacements (new or remanufactured units).

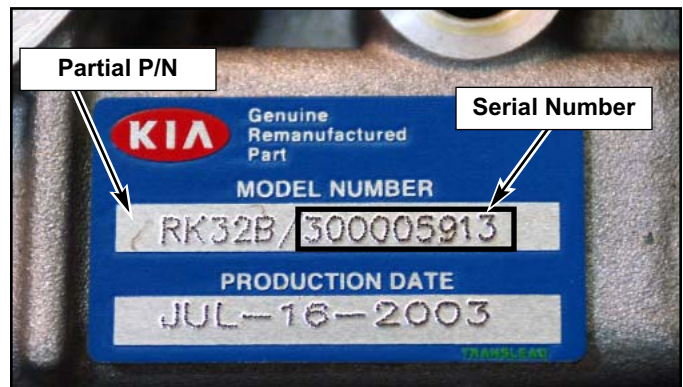
**New Style Reman
Serial Number**

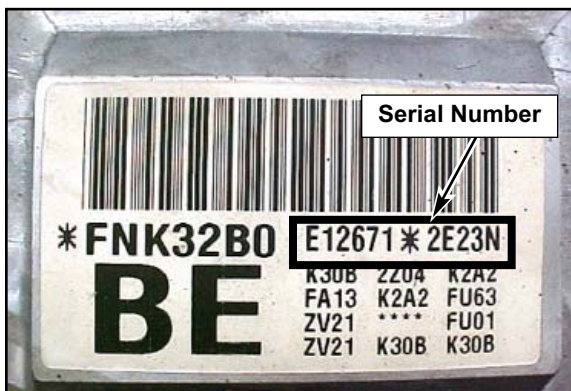
**Old Style Rio/Sephia/Spectra
OEM Serial Number**

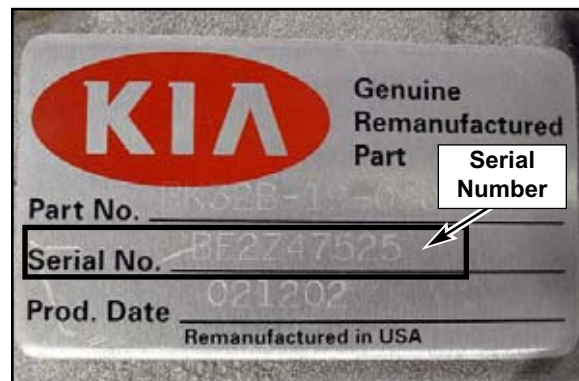
**Old Style Rio/Sephia/Spectra
Reman Serial Number**
