MODEL
Sorento

DATE
December 2004

TECHNICAL SERVICE BULLETIN

SORENTO DIGITAL CLOCK LOSING TIME

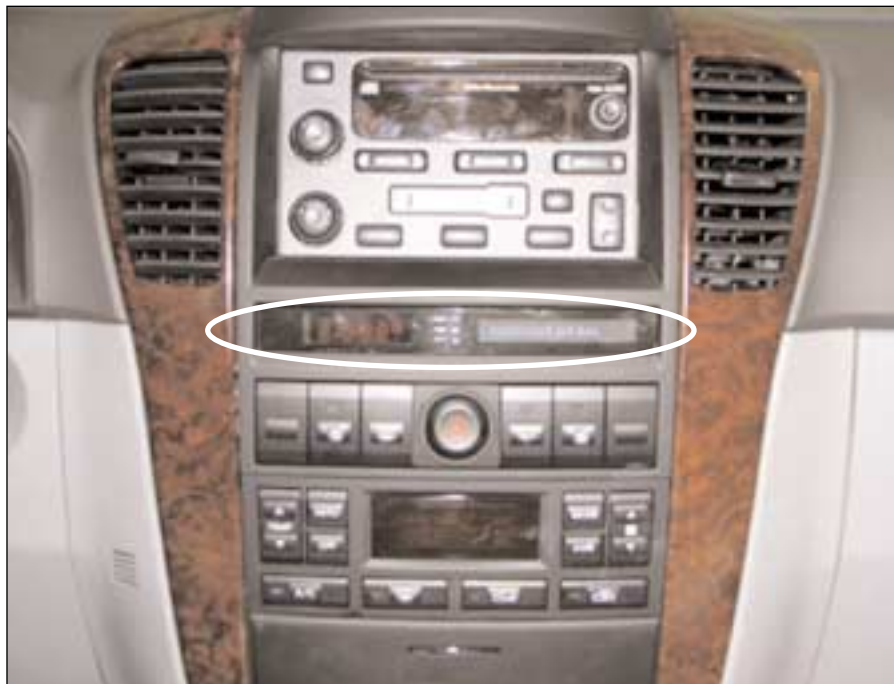
This bulletin provides information relating to replacement of the digital clock assembly. Some 2005 Sorento owners may complain of the clock losing time, the affected production range is from 9/3/04 - 12/17/04. The internal clock logic has been upgraded to prevent this from occurring.

Note: For customer satisfaction, please replace all clocks for dealer stock vehicles within the affected production range.

Please order the clock assembly on an as needed basis. This part number is not eligible for parts return and initial orders will be limited depending upon parts availability.
